# Die Performance von Passivhäusern

# Passivhaus – Langzeiterfahrungen

Untersuchungen nach 25 Jahren Nutzung Passivhaus

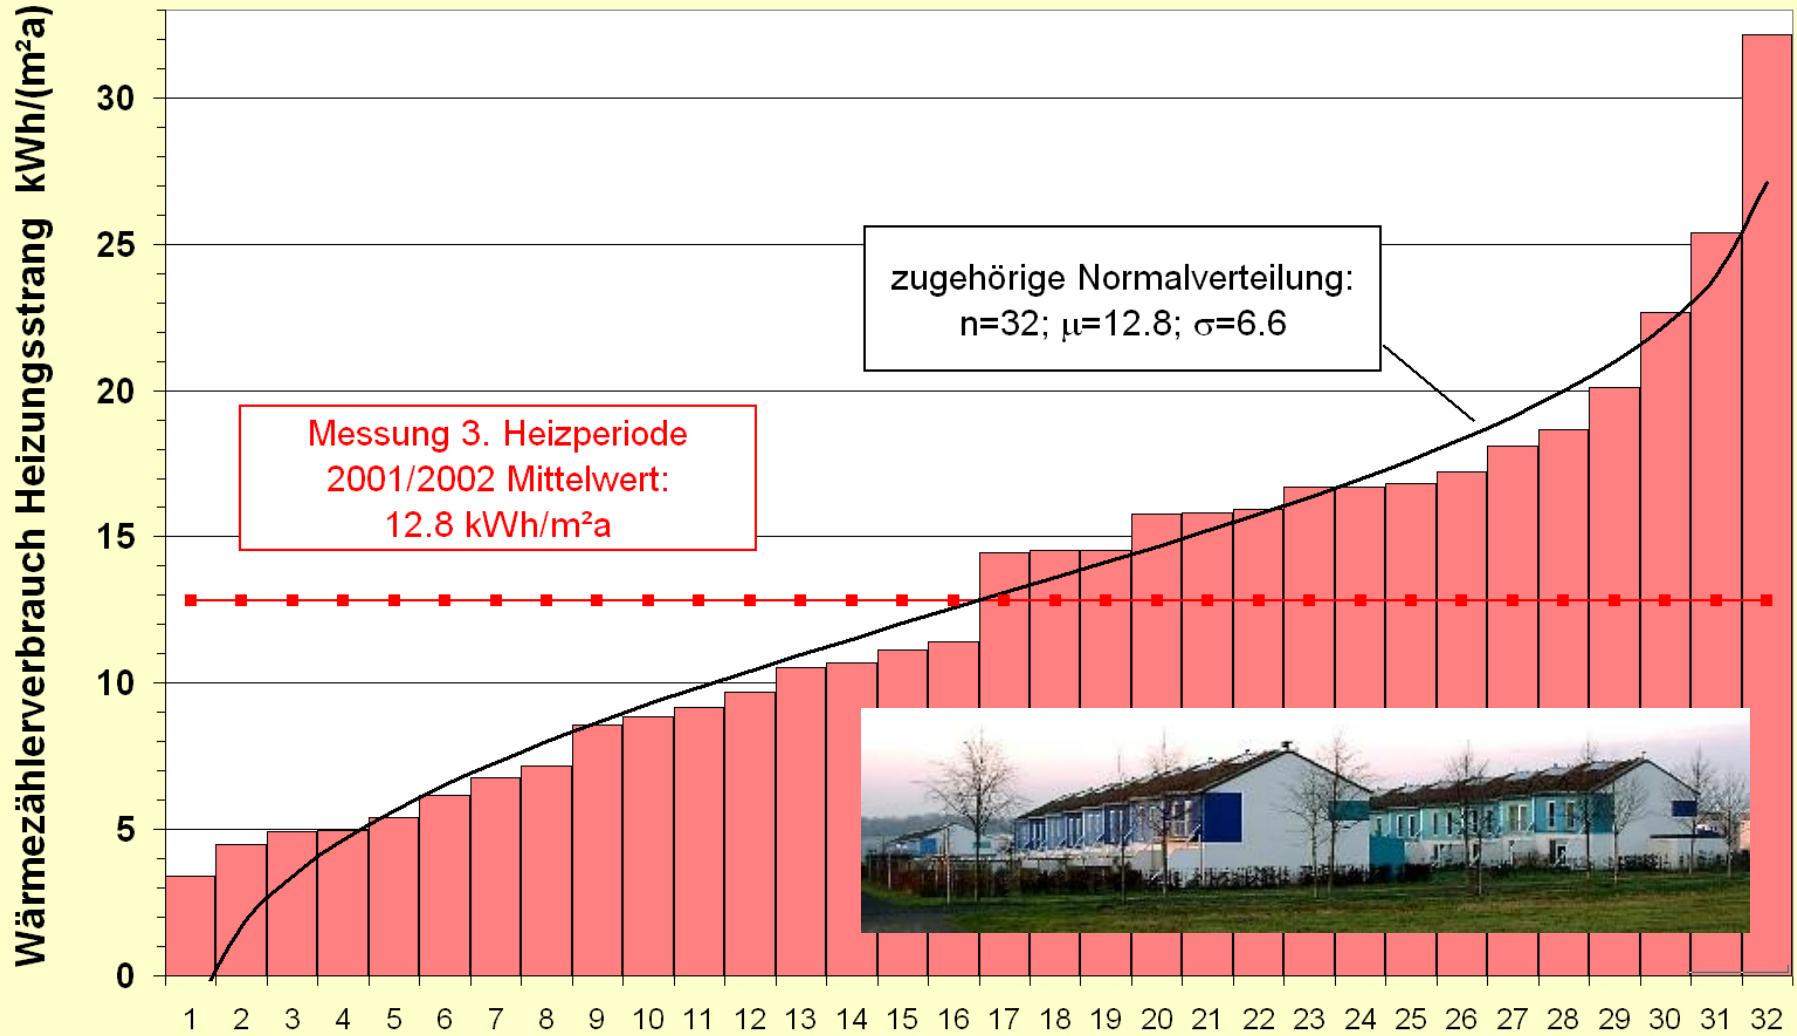
# Messergebnisse Passivhaus-Siedlung Hannover Kronsberg (32 WE)

Genauigkeit des Mittelwertes:  
 $\pm 6.6 / 32^{\frac{1}{2}} \text{ kWh}/(\text{m}^2\text{a}) = \pm 1.2 \text{ kWh}/(\text{m}^2\text{a})$

Zuluftheizung, Fernwärme

Streuung der Einzelwerte:  
 $\pm 6.6 \text{ kWh}/(\text{m}^2\text{a}) = 18.8\% \cdot 35.1 \text{ kWh}/(\text{m}^2\text{a})$

Bezug: Wohnfläche

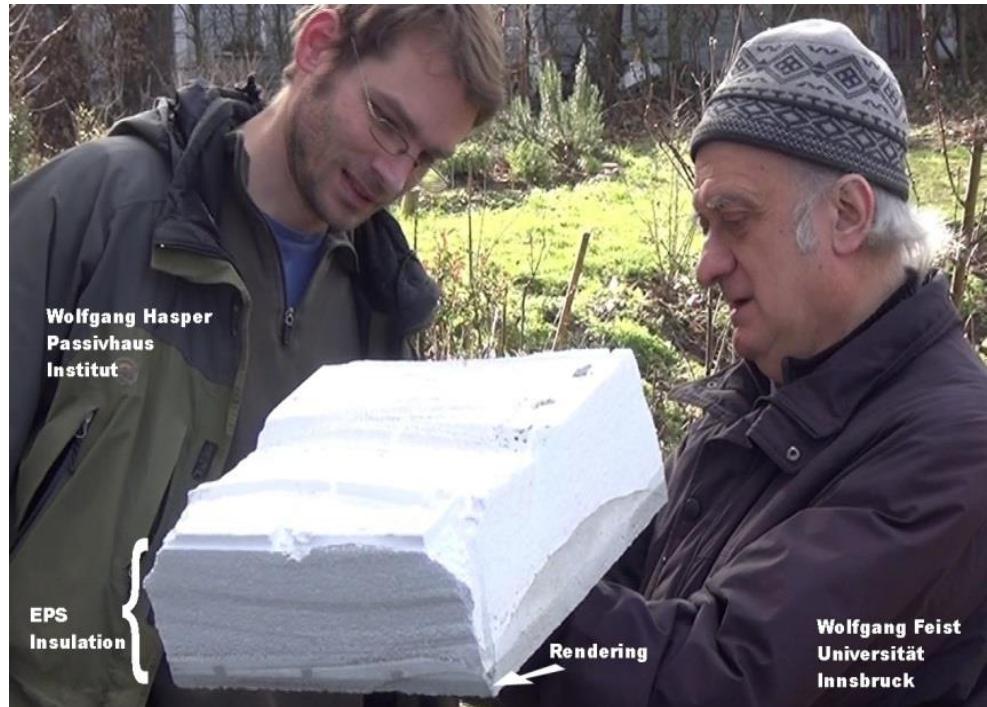
# 275 mm Wärmedämmverbundsystem auf Kalksandstein: Massivwandaufbau im Passivhaus Kranichstein

- Rohdichte 14,92(17) kg/m<sup>3</sup> ✓
- Druckfestigkeit EPS ( $\sigma_{10}$  59 kPa) ✓
- Wärmeleitfähigkeit EPS  
0,0412(12) W/(mK) ✓
- Dynamische Steifigkeit EPS
- Feuchtegehalt EPS  
überall < 0,5 Masse-Prozent ✓

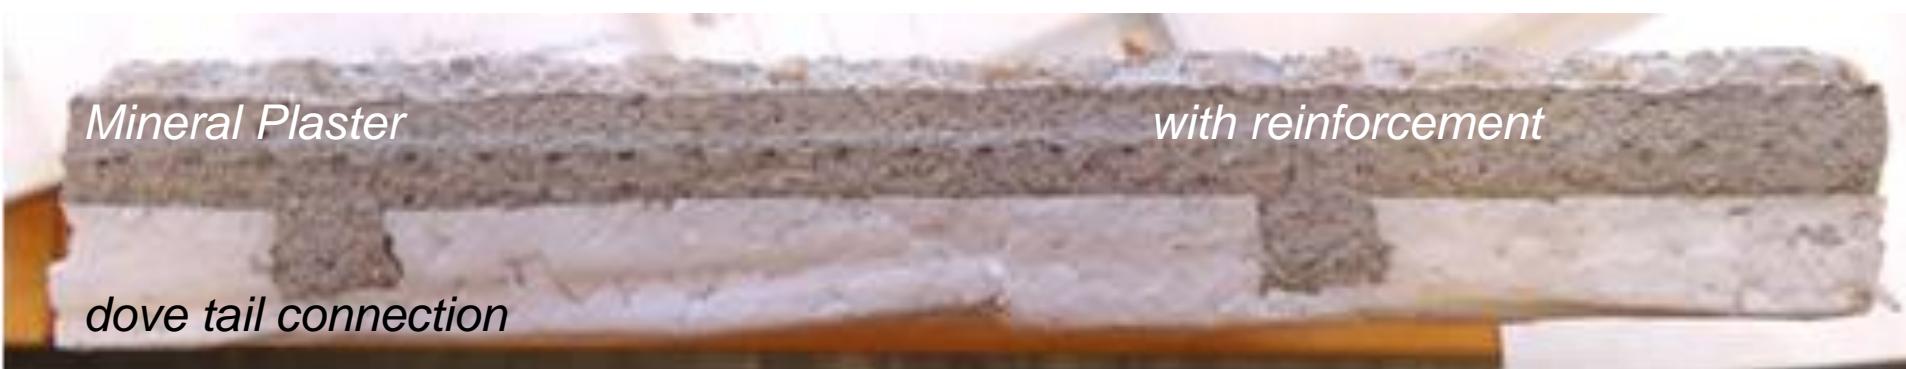
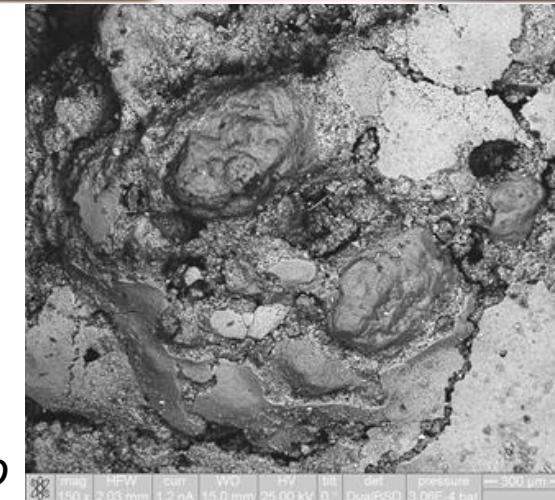
# 275 mm Wärmedämmverbundsystem auf Kalksandstein: Massivwandaufbau im Passivhaus Kranichstein

Mineralische Putzschicht mit Armierungsgewebe

und Schwalbenschwanz-Nuten

Eindruck: „Betonplatte“

Druckfestigkeit 5,3 (1,3) N/mm<sup>2</sup>

„Gemäß dem super Zustand des Systems sollten weitere 25 Jahre kein Problem darstellen.“ Prof. Andreas Sixer; material sciences, UIBK

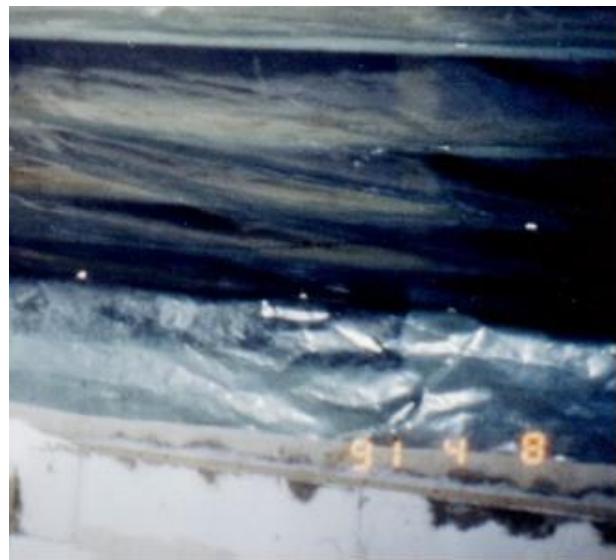
1

Roof: PE-film

wall: gypsum-plaster

**JOINT: film overlapping,  
covered by gypsum**

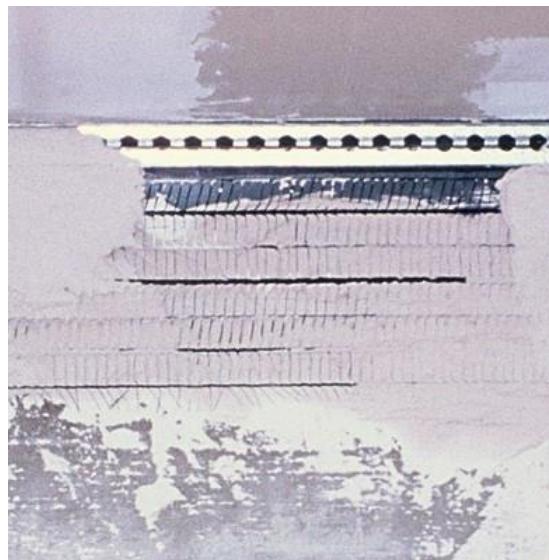
2

**Fixing with  
plaster base**

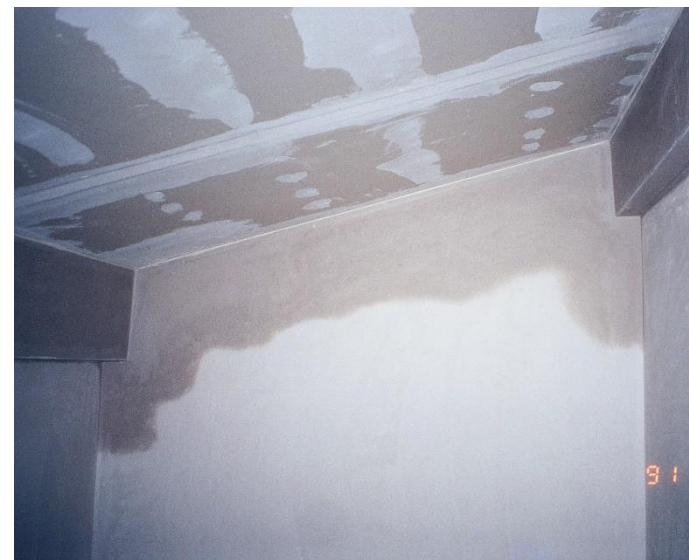
3

**covered with  
plaster  
(longer humid)**

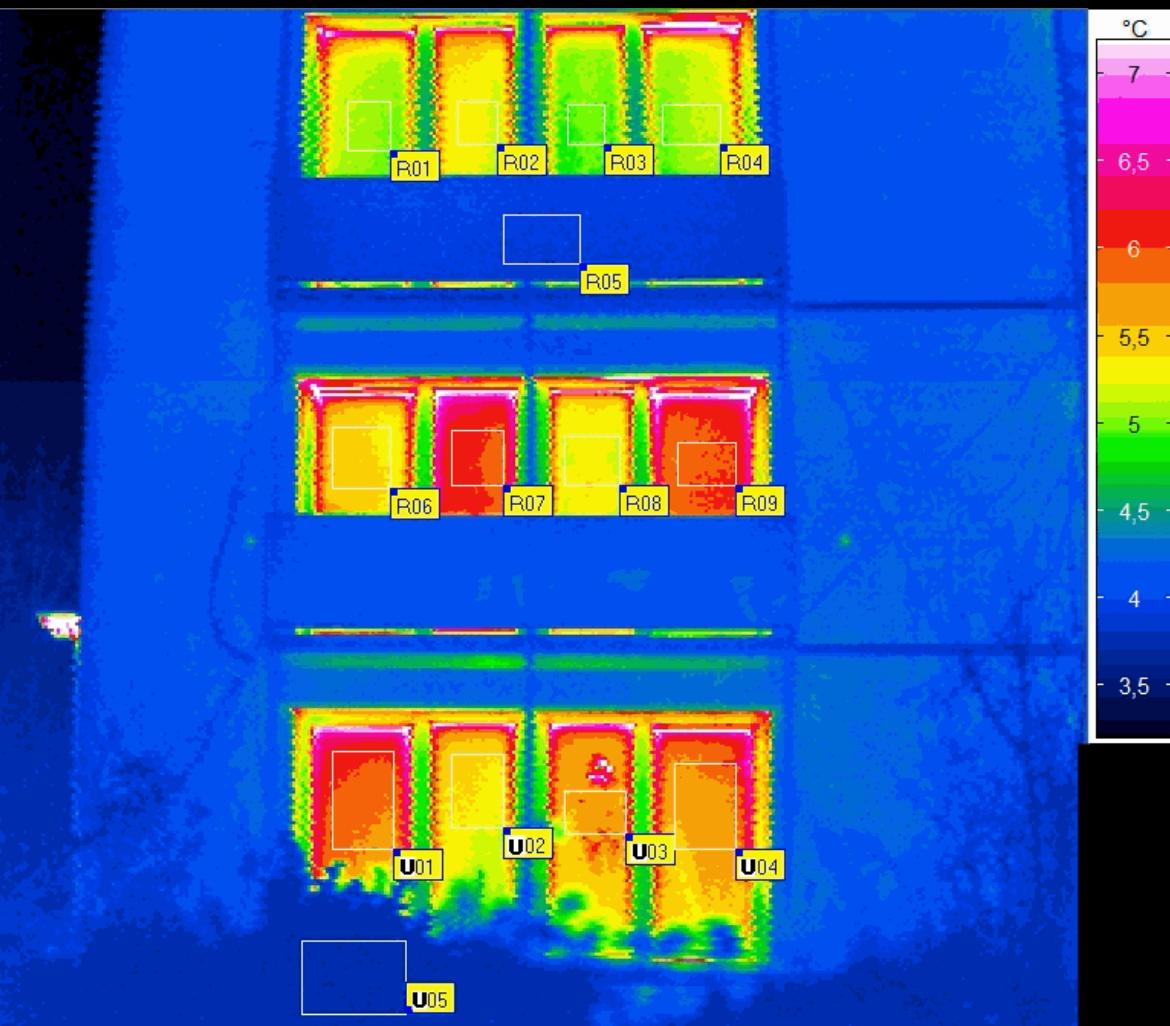
# Energie effiziente Fenster – 25 Jahre und mehr?

*Window panes have  
higher losses  
 $U$  some  $0,8 \text{ W/m}^2\text{K})$   
than the insulated  
wall*

*Gas losses?*

*Spacer  
performance?*

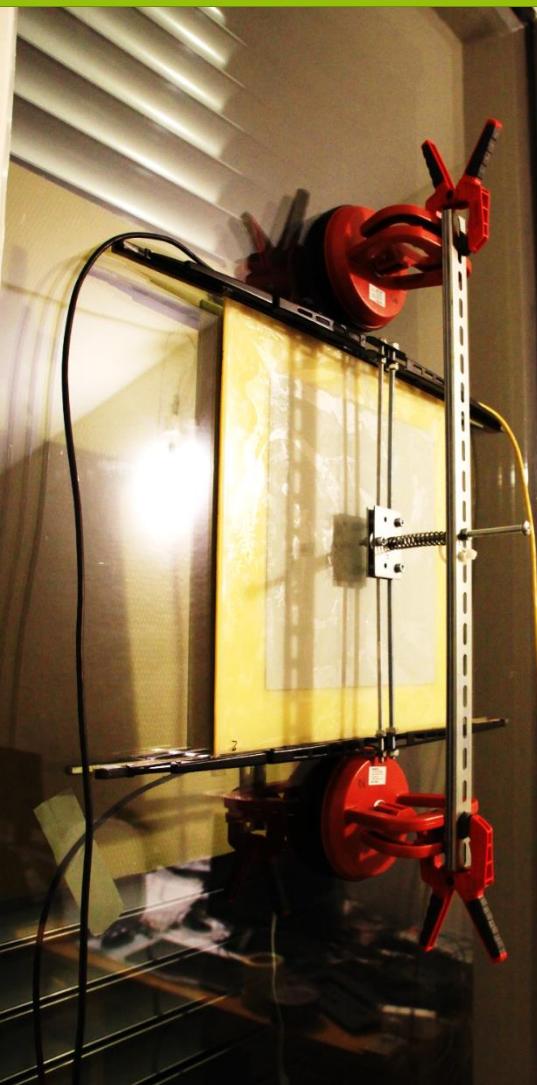
# Dreischeiben Wärmschutzverglasung: Gasverluste nach 25 Jahren?

*Costum made heat flow meter*

*Six  $U_g$  measured on site:*

$$Ug = 0,78(5) \text{ W}/(\text{m}^2\text{K})$$

*(Maximal value 0,97 W/(m<sup>2</sup>K))*

*Gas loss in av. lower than 0,25(10)%/a*

*In some cases (15%) 1,2(2)%/a*

***Result: with exceptions negligible gas loss;  
Life expectance for triple-low-e: 40 yrs***

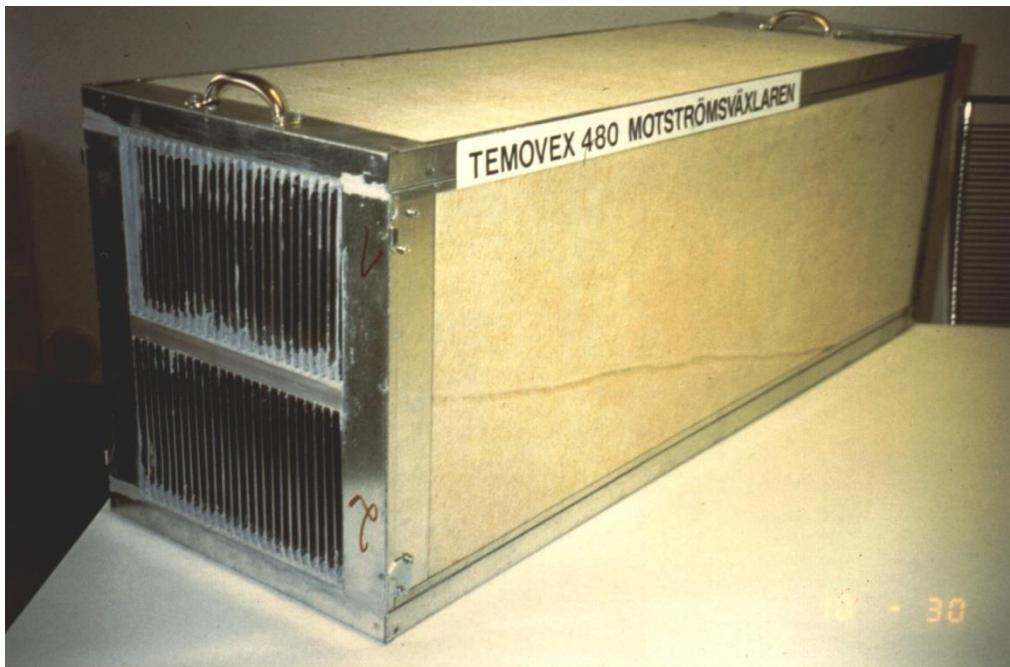
*Heat exchanger from the TEMOVEX heat recovery system. Running 25 yrs:*

- *still tight*
- *still highly efficient*
- *still clean*

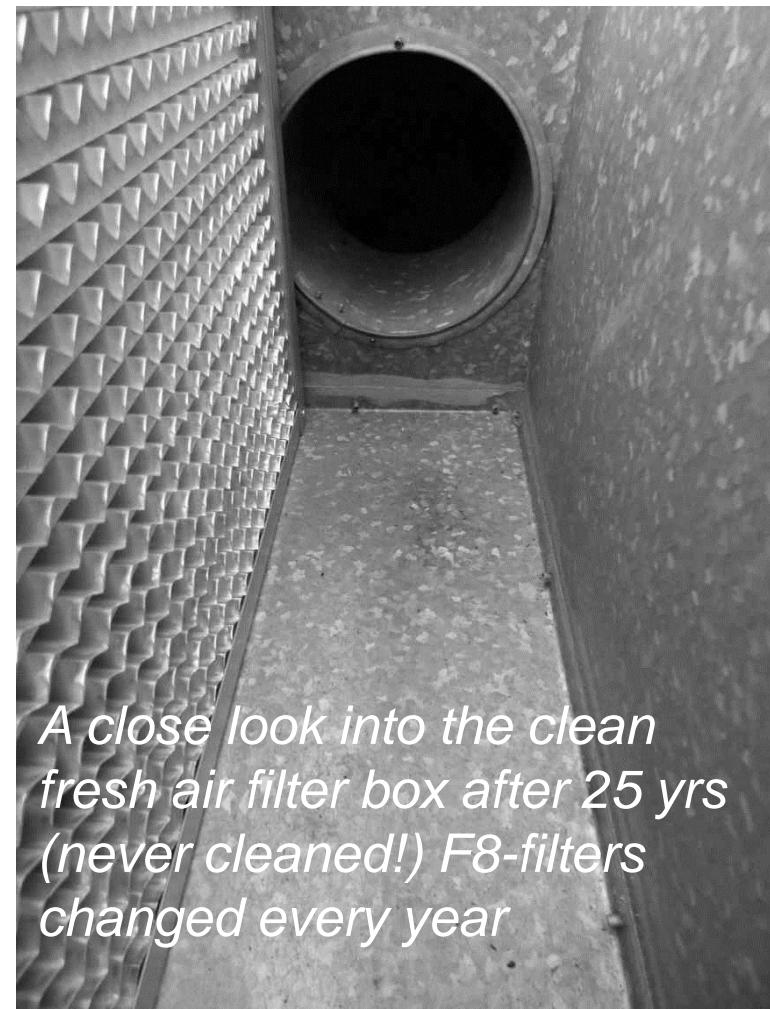
*A close look into the clean fresh air filter box after 25 yrs (never cleaned!) F8-filters changed every year*

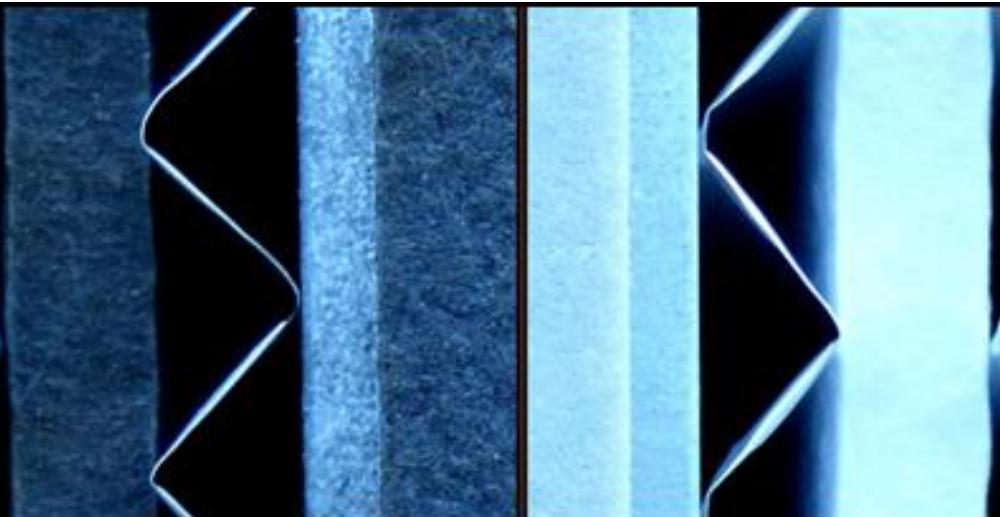
# Zulufttrakt: Hygiene: Dank F8-Filter sauber wie vor 25 Jahren

after 1 year

new

*The F8-Filter keeps the major part of all dust outside the system. Part of the dust are carbon particles and partially burned fuel – this is why the filter becomes black.*

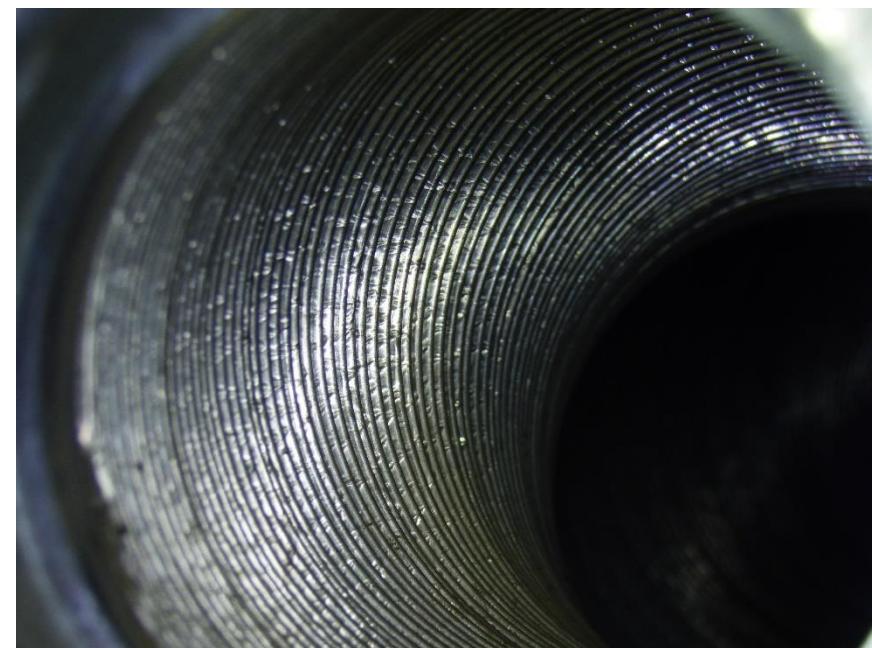
*Supply air duct (silencer) – which has never been cleaned in 25 yrs and as still super-clean – as is the whole fresh air/supply air duct system; because of the F8 filter*

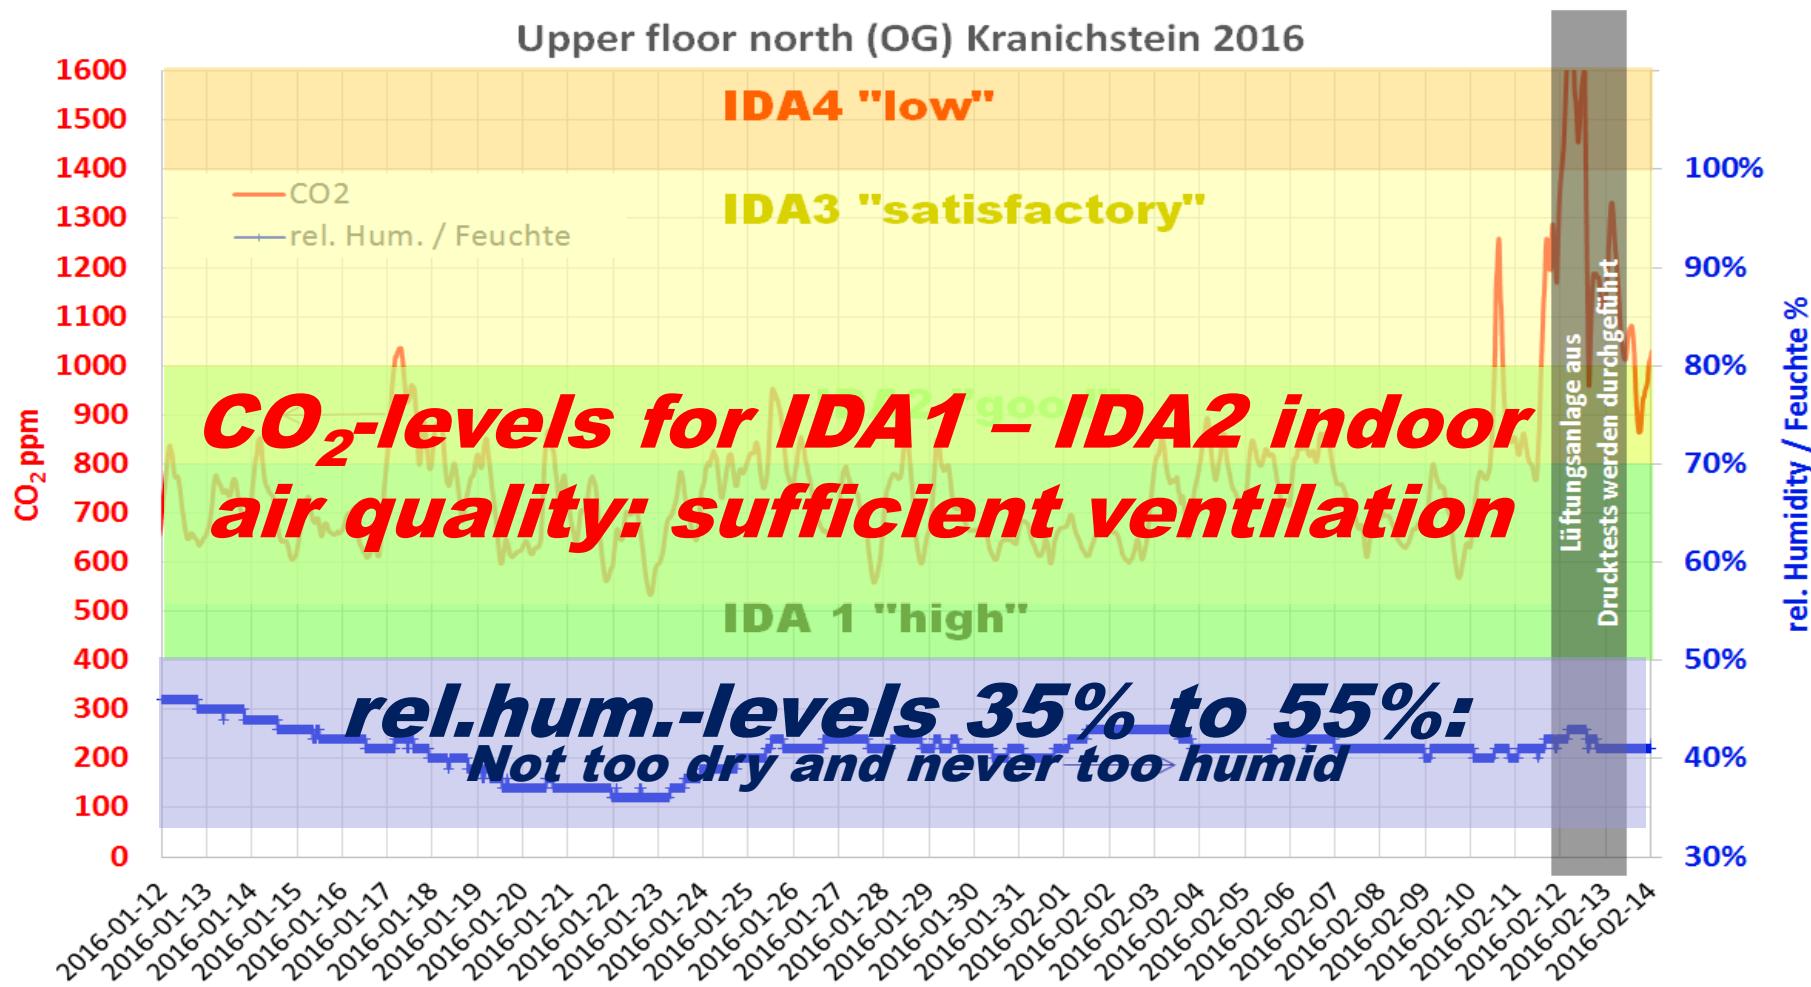
# Innenluftqualität

## Dauermessung CO<sub>2</sub> und Feuchte – in der Regel IDA2

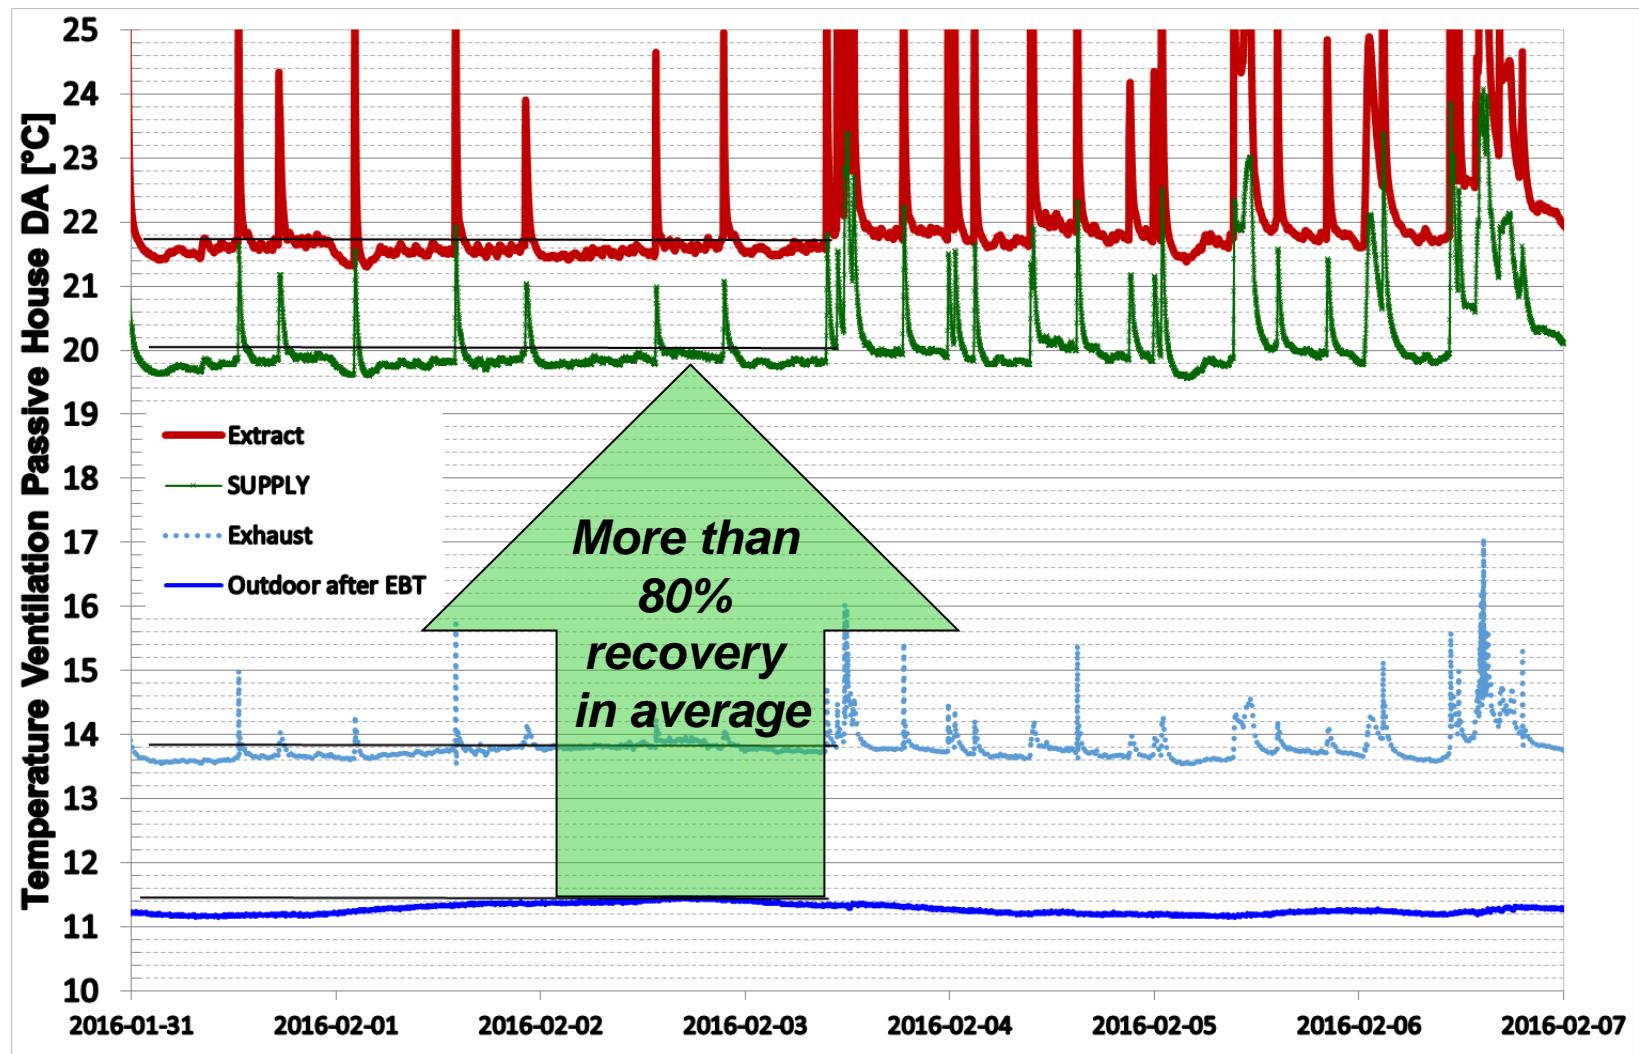
# Effizienz Lüftung: Dauermessung Frisch-/Zu-/Ab- und Fortluft; WBG > 80%

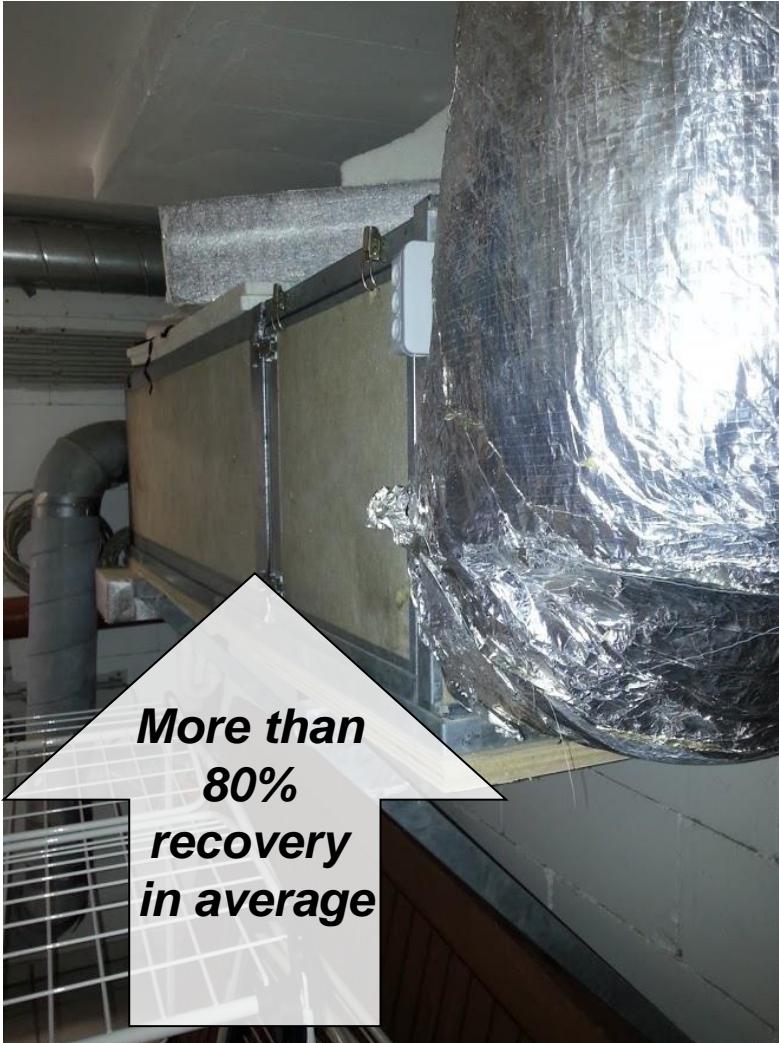
# Zustand WR-Gerät und -Anlage

1) stabil 2) dicht 3) sauber 4) ...nochmal 25 a 5) Ventilator 20 a

*The system is:*

- 1) *undamaged: where is no special strain on any part except the ventilators*
- 2) *airtight*
- 3) *clean; also ducts are clean and undamaged*

*... all will last another 25 yrs. (LCC 50 a)*

*Except: The ventilators will have to be exchanged every 20 yrs.*
